Expert Report

Wadsworth v. Jetson et al

Derek King, M.S., P.E.

July 12, 2024

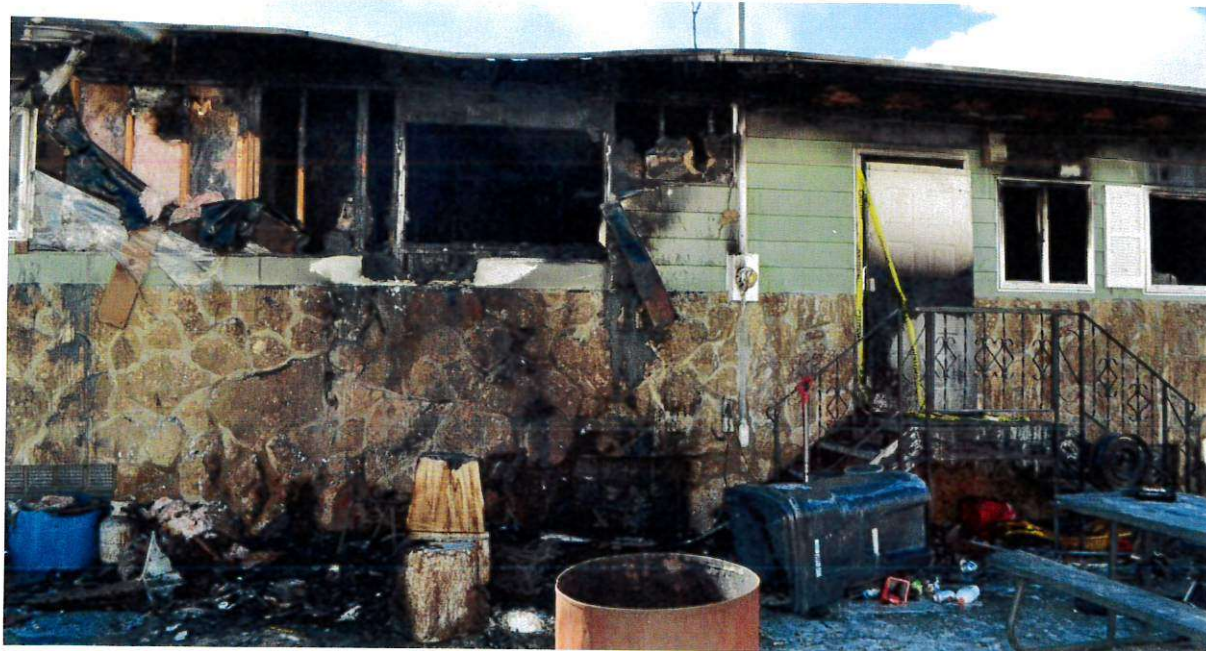
Figure 2: The bedroom window where the subject hoverboard was found.

- An exterior fire would have to rise along the wall, enter through the eaves, and then burn down to eventually reach the subject board. The exterior wall should therefore be exposed to the fire for the longest duration.
- The exterior of the house at and around the window area is substantially less fire damaged than the interior. The exterior wall studs are largely intact. This suggests a shorter and less intense exposure to fire on the outer wall compared to the interior.
- Detective Sheaman observed an interior V-pattern which included studs which were nearly completely consumed by the fire.

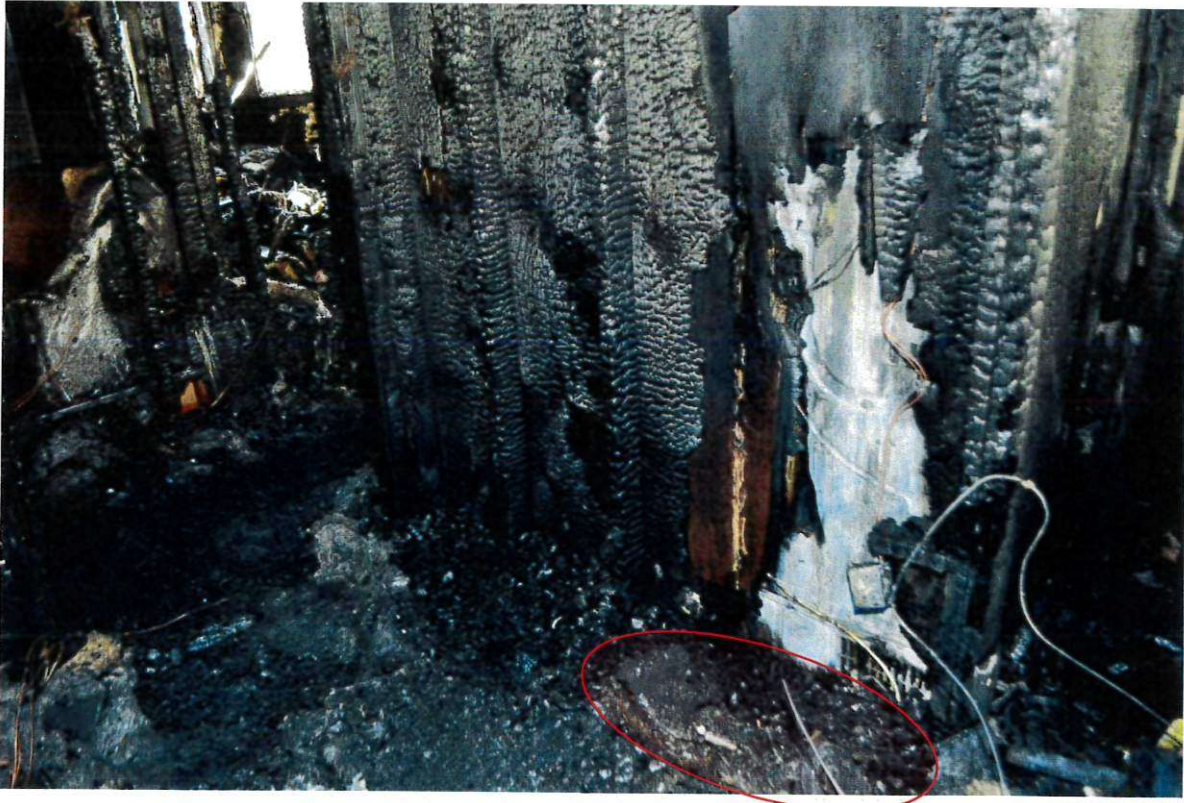
Figure 4: The general location of where the wall V-pattern points. The wall above the subject board (circled) is completely burned away.

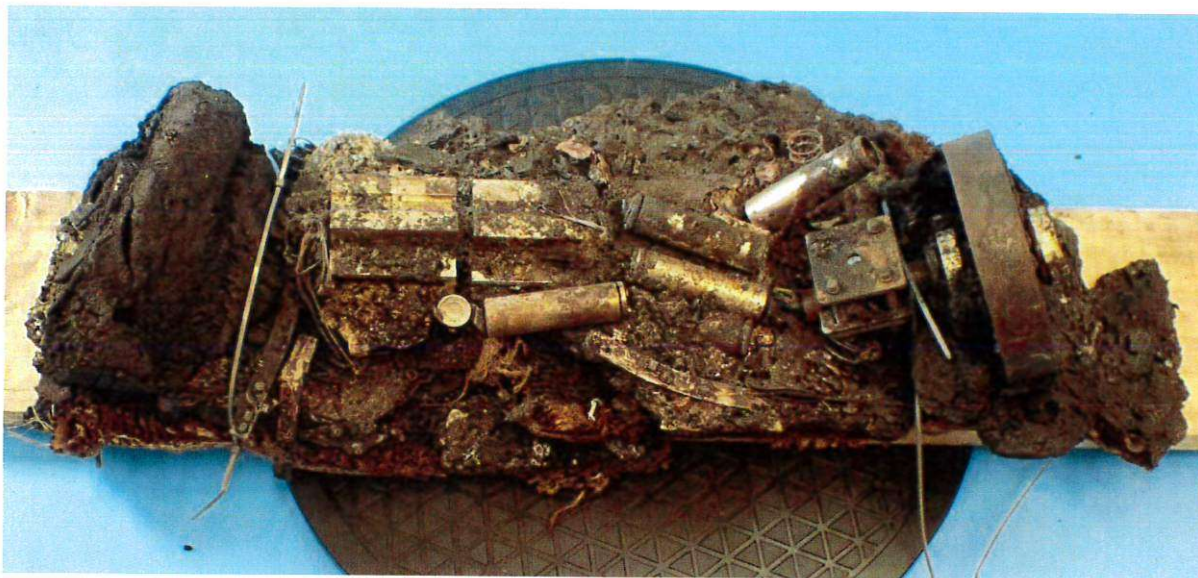
Figure 5: The subject board as-received by BEAR. The wood plank appears to be added for physical support of the loose evidence.

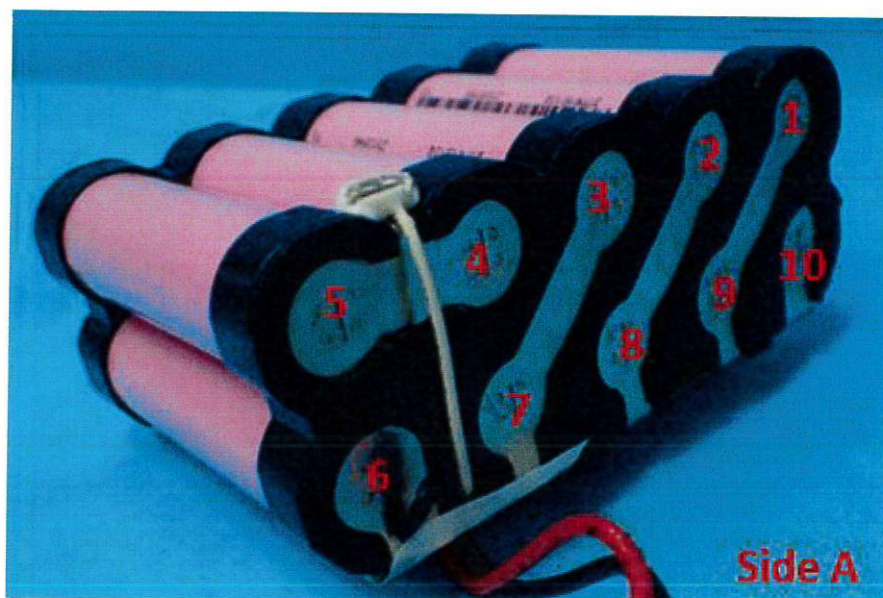
Figure 7: The exemplar battery pack with cells numbered for position reference. The pack with management board has asymmetric features that help identify subject cells.

All 10 cells were collected and inspected. Referring to the cell numbering in the exemplar pack, subject cells 4 and 10 have ruptured and expelled their contents, while the

The difference in cell condition is consistent with cells 4 and 10 experiencing an internal short with thermal runaway and the other cells being damaged due to external heat. As shown in **Figure 7** above, cells 4 and 10 are diagonally opposite of each other within the battery pack – cell 4 is on the top and cell 10 is on the bottom. In addition to the rupture condition, the difference in the ruptured cell locations makes it unlikely that external heat would cause corresponding selective damage.

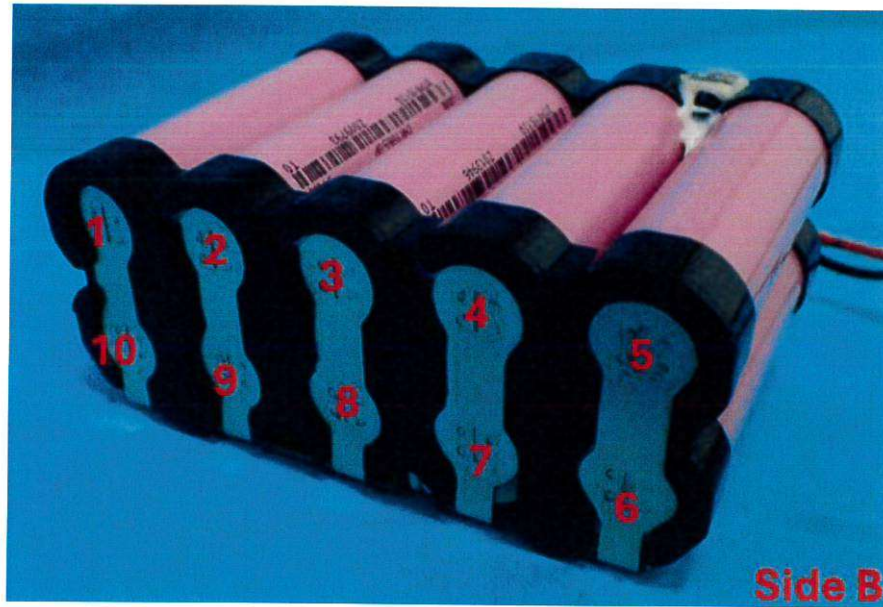
Figure 8: The other side of the exemplar battery pack with cells numbered for positional reference.
